WEATHERING, CONSERVATION AND RESTORATION OF THE SANTA MÓNICA CHURCH IN GUADALAJARA, MEXICO

Karla Jáuregui Arreola¹, Wanja Wedekind² and Siegfried Siegesmund²

¹ *Memento Conservación y Restauración Guadalajara/Mexico*
² *Geoscience Center of Georg-August-University Goettingen/Germany*

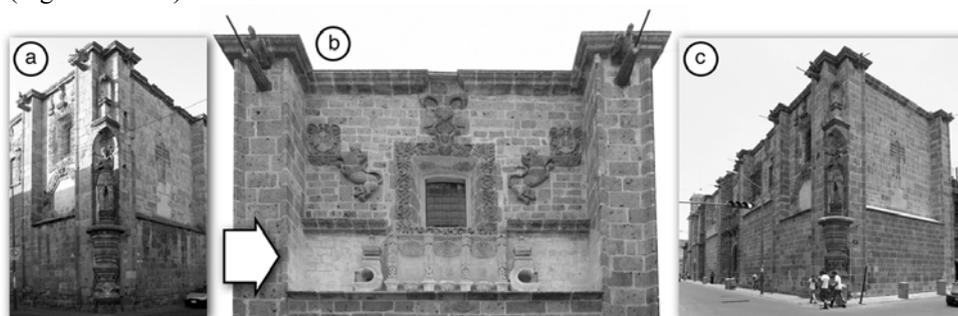
Figure 1. a) Church before restoration. b) Area where architectural elements were discovered (arrow) that include three niches for the placement of religious sculptures. c) Church after restoration.

After these two catastrophic events protection walls up to 7 meters in height were erected between the pillars, which subdivides the façade. By the removal of the upper parts of these protection walls during the restoration in 2009, large-scaled areas rich in decorations were discovered.

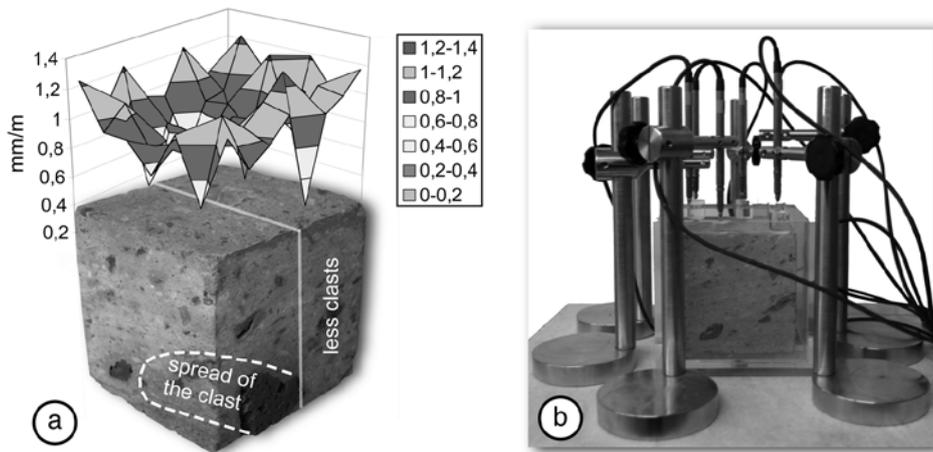
The results of the dilatation experiment on the stone block emphasize the influence of the bedding towards moisture expansion. What becomes clear is that the periphery of the stone shows a higher moisture expansion than the center of the block (Fig. 3a). Furthermore, the large pumice inclusions seem to play a role in keeping the moisture values low. Above the large inclusion there is also a tendency to lower dilatation values, probably due to the lower amounts of matrix. In the sample cube where the concentration of clasts are lower, the dilatation is higher (Fig. 3a).

Figure 3. a) Stone block and results of the dilatation experiment. b) The measuring equipment.

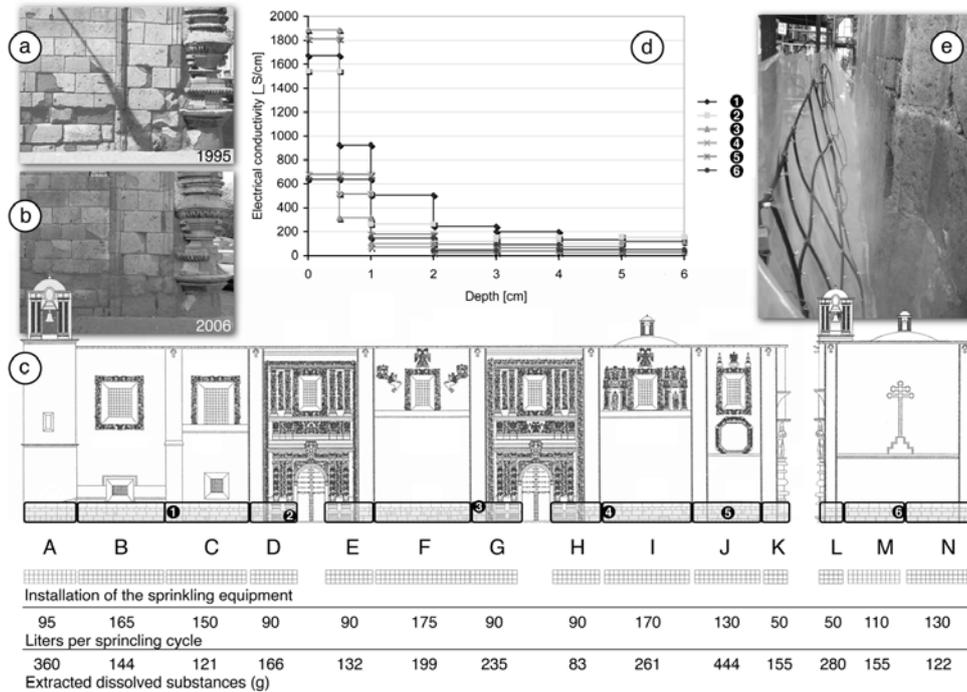
In the foundation area of the Santa Mónica Church as well as other historical buildings extensive back-weathering due to disaggregation and distinct fragmentation is observable. Mapping results indicate a yearly back-weathering rate of 1.7% in the foundation area (Fig. 2a & b). Most of the stones concerned were installed like plates, which means perpendicular to the bedding. Salt efflorescences are recognizable on many building stones. The main salt found is sodium nitrate (NaNO_3) and gypsum analysed by X-ray diffraction (XRD) measurements. The highest concentration of contamination occurs in the first two centimeters of the stone material as evaluated by the drilling powder analysis method (Fig. 4d).

Figure 4. a) Degree of back-weathering in 1995 and b) around 10 years later in 2006. c) Architectural drawing of the façade. Areas for desalination (A-N) and sampling points for drilling powder analysis (1-6) are indicated. The schematic grid depicts the location of the sprinkling equipment. Quantities of water used and the amount of dissolved substances extracted are given below. d) Salt contamination with depth. e) The sprinkling equipment being applied.

For salt reduction a sprinkling method was applied, which was developed for the desalination of salt-contaminated areas on rock cut facades in Petra/Jordan (Wedekind, Ruedrich 2006). In front of the contaminated areas of the church a grid-like system consisting of pipes was installed (Fig. 4e). Each pipe contains a nozzle and was placed at a distance of 40 cm to the next one. At the bottom of the wall a sheet of plastic was cemented in a horizontal joint to catch and drain the excess water. The façade was divided into 14 areas from A to N (Fig. 4c). During the desalination process water is sprayed onto the wall surface through the nozzles. Water absorption occurs immediately into the porous stone surface. Depending on the sprinkling duration, a little or more water seeps into the stone, whereby the depth penetration can be adjusted accordingly.

The water not absorbed by the stone runs off the wall, is drained in a controlled way and sampled. Electrical conductivity is measured in a 5 liter container to determine the influence of dissolved substances.

The highest concentration of dissolved substances is found during the first application of the first measuring with the washing water and then the concentration levels out to a certain amount. The procedure is then stopped. After a few days of drying a second sprinkling cycle is initiated. The first collected liters in the second cycle also contains a high concentration of dissolved substances. However, this increase in concentration did not reach the starting level of the first sprinkling cycle. For each subsequent washing a lower content of salt was brought to the surface. After four to five cycles the salt concentration should eventually decrease in a stepwise fashion. A significant reduction of the salt content within the stone can be determined by the drilling powder analysis method.

To calculate the total amount of the extracted dissolved substances, samples of a specific quantity of the collected washing water is first measured by electrical conductivity and then evaporated in a heating chamber. After complete evaporation the weight of the residue is measured and related to the value of the electrical conductivity. By taking the sum of the weights and the individual electrical conductivity values, a

quotient can be calculated by linear regression. As an approximate value a total amount of 2,857 g could be extracted from wall from the sum of all the individual areas in the wall. This equals a daily extraction of around 22 g/m² on average.
