Evaluation of desalination and restoration methods applied in Petra (Jordan)

Fourth International Conference on Salt Weathering of Buildings and Stone Sculptures

Wanja Wedekind* and Helge Fischer
Applied Conservation Science (ACS), Goettingen/Berlin, Germany
* wwedekind@gmx.de

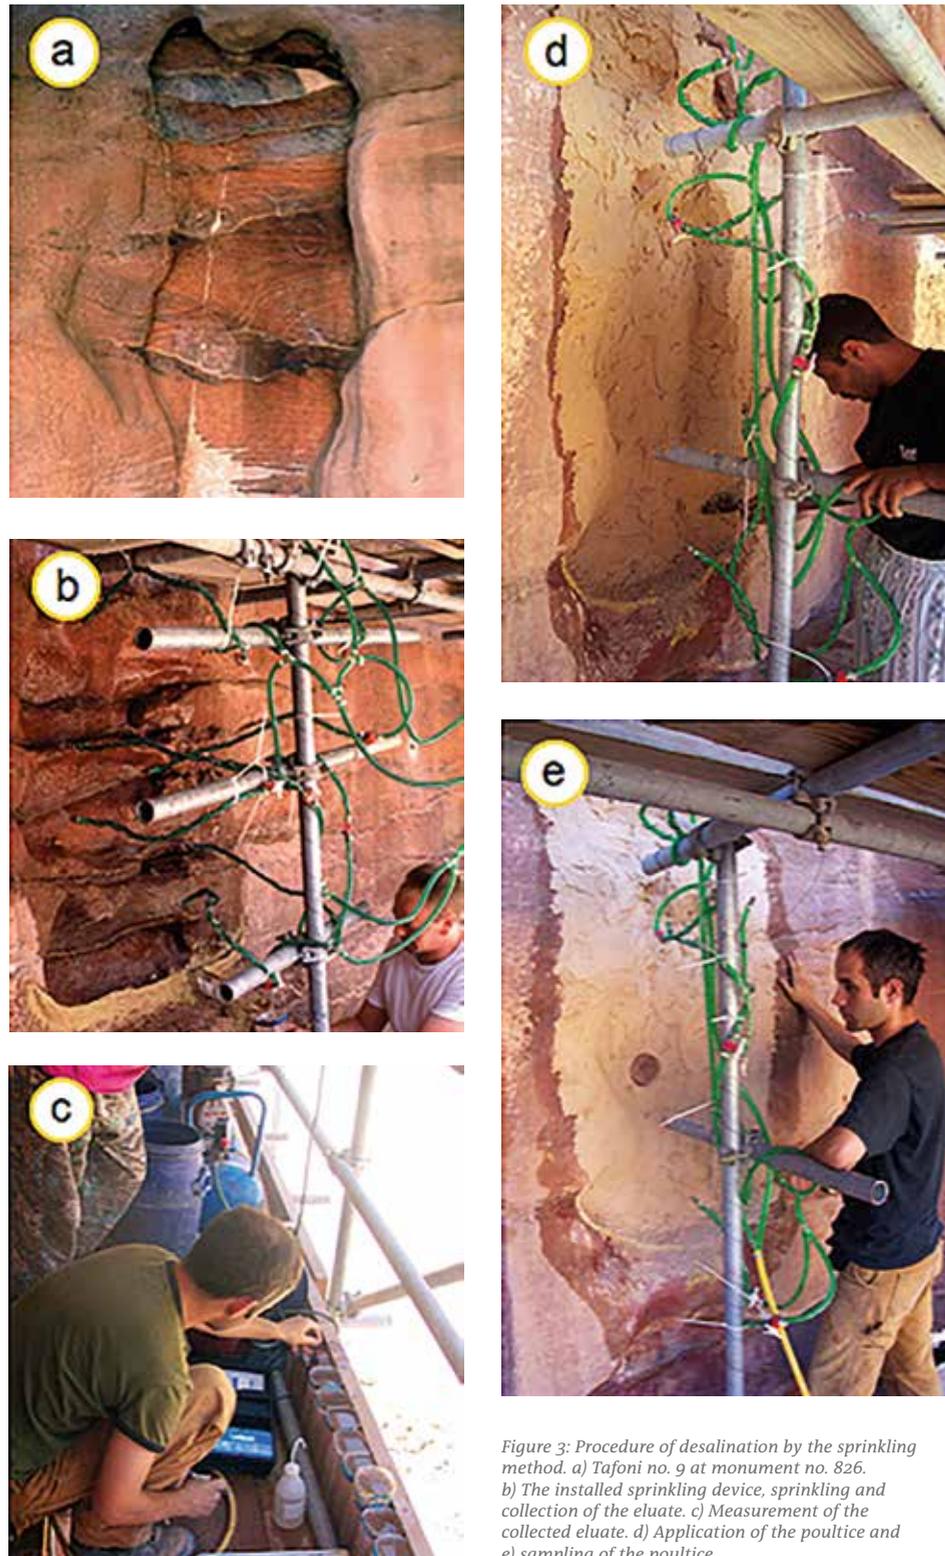
Figure 3: Procedure of desalination by the sprinkling method. a) Tafoni no. 9 at monument no. 826. b) The installed sprinkling device, sprinkling and collection of the eluate. c) Measurement of the collected eluate. d) Application of the poultice and e) sampling of the poultice.

By this method water is sprayed onto the stone wall surface through fine nozzles (Figure 3b). At the start of this procedure water is predominantly absorbed by the porous stone surface through capillary forces. Water absorption is dependent upon the transport properties of the rock and these are essentially controlled by the pore space properties, like porosity and pore radii distribution and are a time-dependent process.¹⁵

The excess water not absorbed by the stone runs off the treatment area and is collected at the bottom in 1l containers (Figure 3c). Electrical conductivity of the eluate of each sample container is then measured thus giving an indication of the amount and concentration of the dissolved substances (Figure 3c). After the sprinkling a poultice of the same composition as used in previous applications was applied onto the treated area (Figure 3d) in order to detect if additional salt would be extracted that way. A sample taken therefrom (Figure 3e) was dissolved and tested by electrical conductivity,

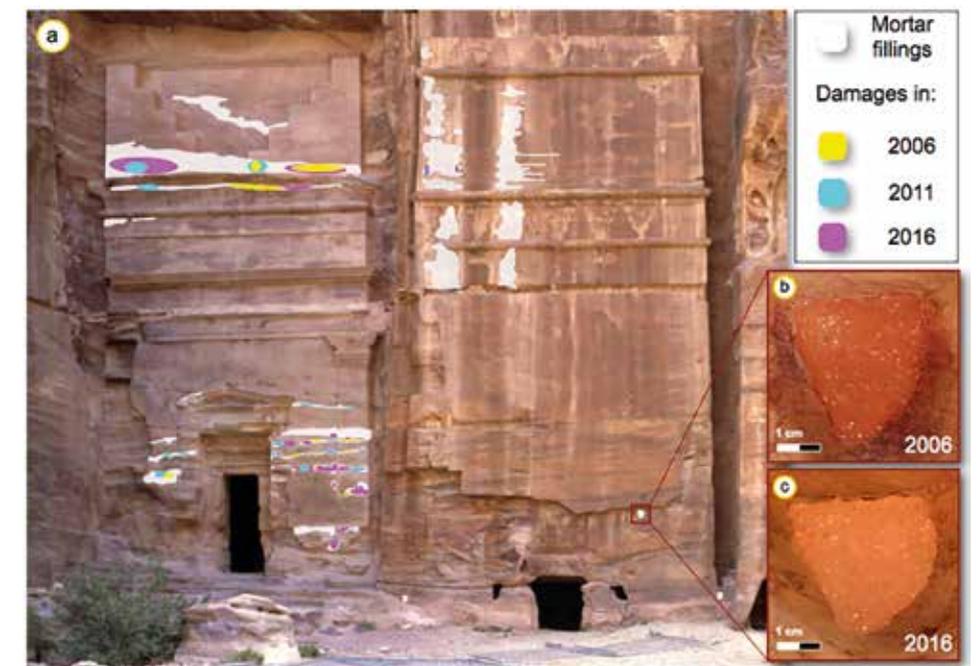
Figure 4: a) Ongoing damage progress of restored areas treated with silica-sol mortars during a period of 15 years on monument 825. b) Sample of a dry-slaked lime mortar just after application in 2006 and c) after 10 years.

Taking into account the particular conditions encountered in Petra, where e.g. the extended presence of a scaffold structure in front of a monument can be an issue, the use of the more efficient and faster sprinkling method for desalination constitutes an additional advantage. Fifteen years after the application of silica-sol-mortar in areas treated this way, the mortars can still be seen to exhibit almost no sign of degradation, in contrast to the observations made on monument 825 treated with the previous method as shown in *Figure 4*.

While five years after restoration only a few damages in the restored areas could be observed on both monuments, around 10 years later almost all mortar applications were affected by crumbling on monument 825 (*Figure 4a*).

As can be seen on monument no. 826, only very slight signs of degradation could be observed 10 years after the conservation treatment. (*Figure 4a*).

Interestingly, a lime mortar newly devised by one of the authors also exhibits no signs of alteration after 10 years (*Figures 4b and c*), indicating that there is also room for the development of alternative the repair mortars. Results of this potentially also far more economic effort will be presented in a separate paper.
