## **SCIENCE and ART: A Future for Stone**

**Proceedings of the 13<sup>th</sup> International Congress on the  
Deterioration and Conservation of Stone – Volume I**

# **GEOLOGICAL STUDIES ON VOLCANIC TUFFS USED AS NATURAL BUILDING STONES IN THE HISTORICAL CENTER OF SAN LUIS POTOSI, MEXICO**

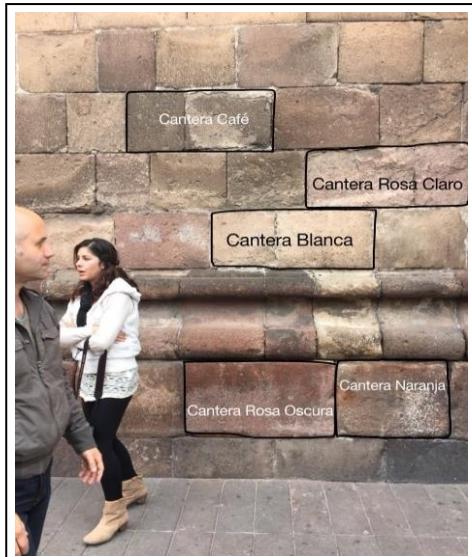
Fig. 2: North wall of the Templo del Carmen. Five variations of the Cantera Rosa can be distinguished here. Cantera Café (brown), Cantera Rosa Claro (light pink), Cantera Rosa Oscura (dark pink), Cantera Naranja (orange) Cantera Blanca (white).
