SCIENCE and ART: A Future for Stone

**Proceedings of the 13th International Congress on the
Deterioration and Conservation of Stone – Volume I**

WEATHERING AND DETERIORATION OF BUILDING STONES IN TEMPLO MAYOR, MEXICO CITY

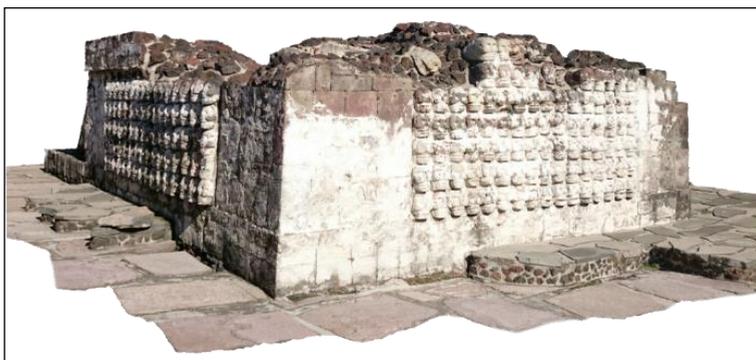
The Edificio B, a rectangular platform of approximately 7.8 meters E-W, 5.48 meters N-S, and 2.4 meters high, with a distinctive decoration of carved skulls in its façades, was excavated in the early 1980s (Fig. 1). Because of its location at the Northwest side of the Great Temple and its decoration, the Edificio B has been interpreted as representative of the *Mictlampa*, the land of the dead in the Mexican cosmovision. The construction presents different stages, the last one being temporarily associated with the sixth construction stage of the Templo Mayor, during the ruling of the *tlatoani* Ahuizotl (1486-1502 AD; Matos Moctezuma 2003).

Fig. 1: Edificio B, Templo Mayor Archaeological Site.

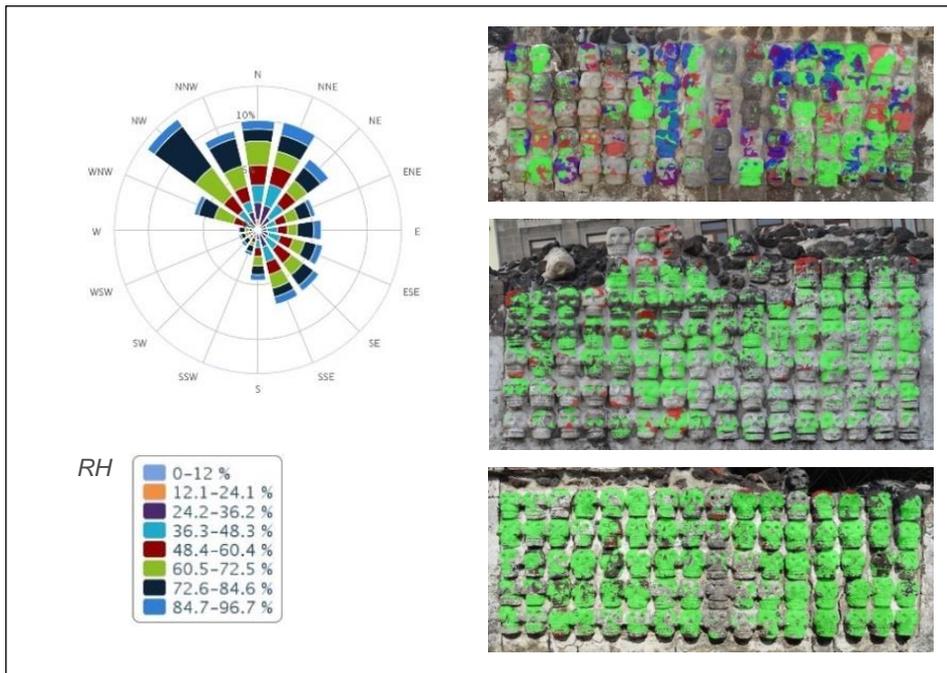
Weathering effects observed on the façades of the Edificio B are the result of complex decay phenomena that affect volcanic stones by different mechanisms. As a result of the environmental exposure, tuff stones are less preserved than vesicular basalts or *tezontle* that shows significant resistance to weathering. Interaction of pollutants with stone materials is higher on the North façade due to the direction of prevailing winds and low insolation that leads to high humidity conditions. In this façade only 18% of lime renders are preserved, 12% of the surface remained wet by October when rainy season was already over, and 9% showed contour scaling, weathering form frequently associated with salt efflorescence. In the East façade lime renders are preserved on 20% of the surface, while the areas affected by weathering processes represent less than 1%. The South facade shows the best condition, 51% of the surface preserve lime renders and remains of polychrome decoration, only 0.3% of the surface is affected by weathering processes (Fig. 2).

Fig. 2: RH values according to the direction of prevailing winds, weathering (red), wet areas (blue), and lime renders preserved (green), on the North, East and South façades.

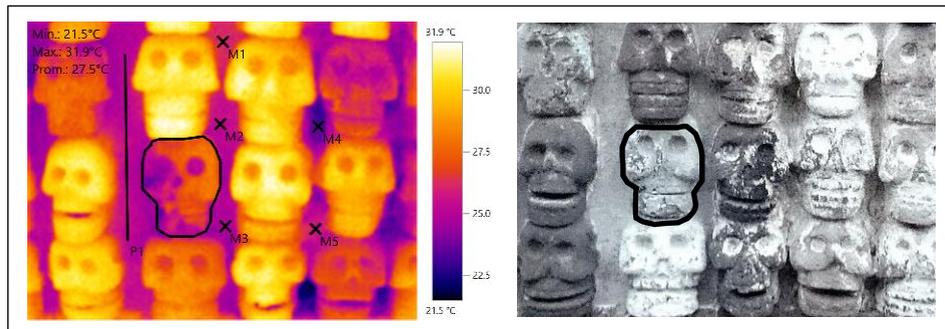
Hygroscopic behaviour significantly determines the resistance of building stones to weathering conditions because it prevents or promotes water, soluble salts and contaminants transport, leading to the mentioned degradation mechanisms. Such behaviour is controlled by the amount of swelling clay minerals and the size and distribution of active capillary pores (micropores of 0.1 to > 100 μm) (Ruedrich *et al.*, 2011, López-Doncel *et al.*, 2013, Wedekind *et al.*, 2013). The concentration of capillary pores in the weathered zones of stones increases and thus the penetration and retention of water, while hardness decreases. Therefore, interaction between materials with marked differences in thermal and hygroscopic behaviour accelerates decay of the more hygroscopic and less resistant ones, as can be observed in tuffs surrounded by vesicular basalts in the North façade, under prolonged wetness conditions. Through thermographic analysis it was possible to confirm that the loss of lime render finish increases significantly differential thermal stress in the most exposed carvings (Fig. 3).

Fig. 3: Thermal image showing differences in lime mortar junctions, tuff and basalt carvings behaviour.
