WEATHERING, CONSERVATION AND RESTORATION OF THE SANTA MÓNICA CHURCH IN GUADALAJARA, MEXICO

Karla Jáuregui Arreola¹, Wanja Wedekind² and Siegfried Siegesmund²

¹ *Memento Conservación y Restauración Guadalajara/Mexico*
² *Geoscience Center of Georg-August-University Goettingen/Germany*

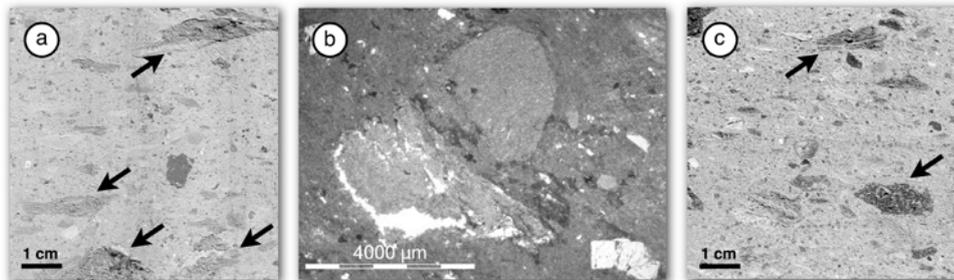
Figure 2. a) The Cantera Amarilla Tuff shows a secondary iron-rich cementation with a vertical orientation and brown iron-rich pumice inclusions (arrows). b) Thin section showing the glassy to microcrystalline matrix. In the center a fragment of feldspar and pumice occurs that only shows a poor cementation within the matrix. c) Cantera Amarilla with dark colored inclusions, rock fragments and pumice (arrows).

The Cantera Amarilla Tuff belongs to the Quaternary volcanics in the Guadalajara area occurring one to two meters beneath the soil. Today most of the deposits are covered by the present urban area. Only a small outcrop is still open for mining the stones for restoration purposes. The rock is a yellowish to orange-brownish porphyritic tuff containing clasts with very different sizes (Fig. 2a and b). The clasts are poorly flattened, light brown to brownish-red pumice and other lithoclasts, which are fine- to medium-grained (sand size), up to 10 cm or even coarser. Most of the pumice inclusions are not well-cemented to the matrix (Fig. 2 b).

The thin section in Fig. 2b shows a hypocrySTALLINE to aphanitic texture. The matrix is reddish to yellowish, glassy to microcrystalline and poorly welded. The macroclasts are mainly pumice, but other lithic clasts such as basalt and other pre-existing volcanic fragments occur. Crystals are essentially platy and tabular and subhedral to euhedral. They consist of well-twinned alkali-feldspar phenocrysts, subrounded to angular reworked quartz and unidentified opaque crystals.
